Report No. 0414-01-3
(Quarterly)

STRESS CORROSION CRACKING OF HIGH STRENGTH STEELS

INVESTIGATION OF STRESS-CORROSION CRACKING
OF HIGH-STRENGTH ALLOYS

AEROJET-GENERAL CORPORATION
Azusa, California

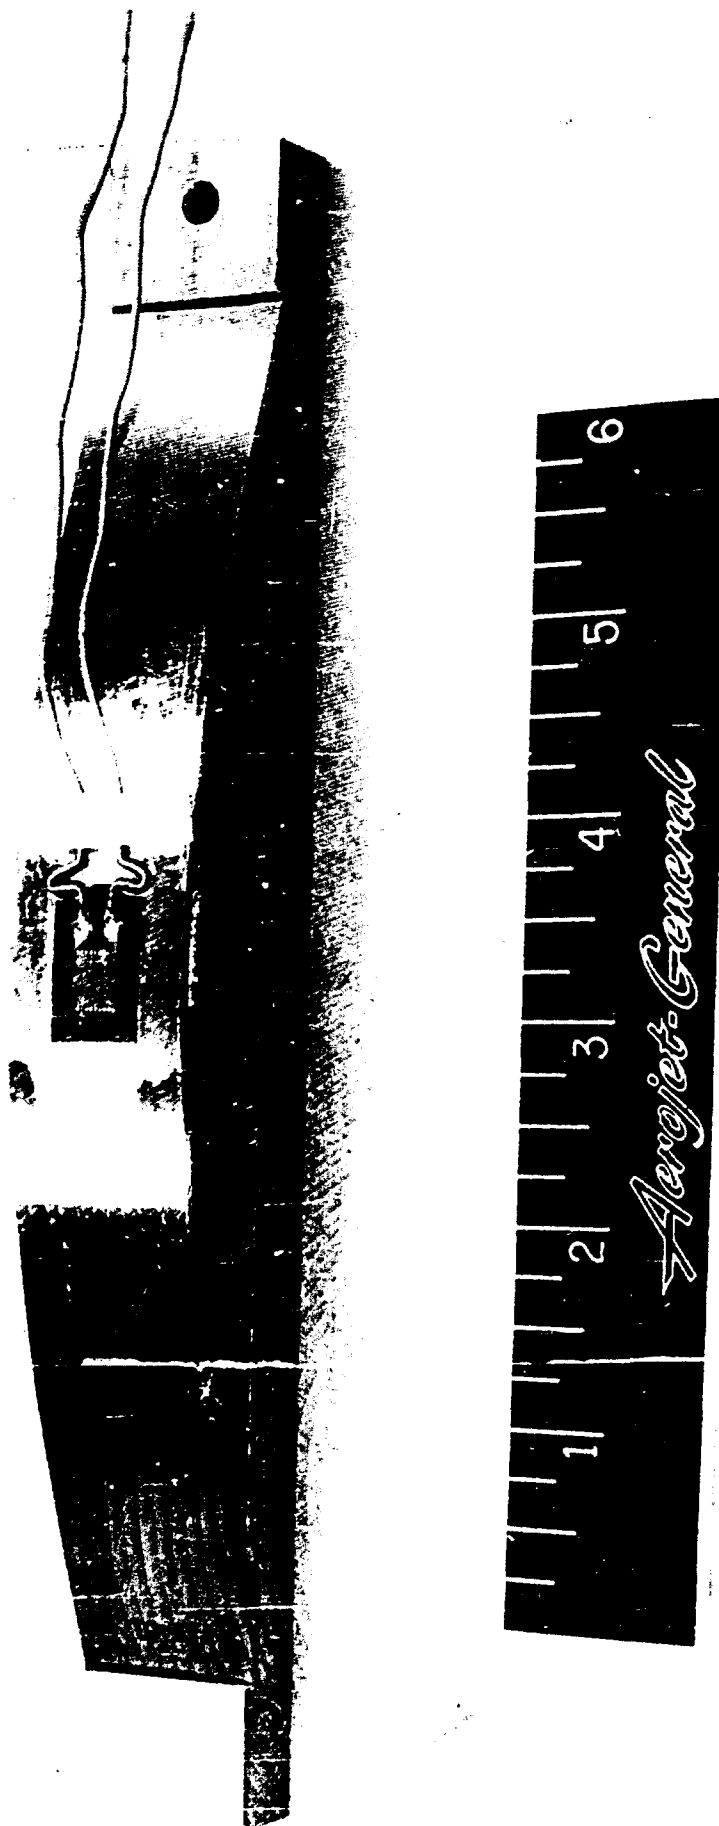
Test Specimen with Strain Gage Mounted,
Stressed in Fixture

In order to obtain a more accurate reading of the actual stresses obtained in the bent-beam specimens, Tatnall C6-141 foil-type strain gages, mounted longitudinally in the center of the top surface of selected specimens

(see Figure 3), were used to make a spot check. By taking strain-gage readings both before and after the specimens were stressed, the actual strain of the beam was obtained (in microinches). The maximum induced tensile stress was therefore computed by employing Hooke's law. However, the values obtained by the strain-gage method were considerably higher than those calculated from the tables (see Table 1). As a result, the environmental phase of the program was delayed until the problem was resolved. Dr. Phelps was consulted but required additional time for further consideration. In the meantime, the environmental stress-corrosion testing was resumed, because further delay in this phase of the program could not be tolerated without seriously hampering the overall progress.
